Town of Dumfries
Council Meeting

AGENDA ITEM: Quantico Creek Update

QUANTICO CREEK STREAM RESTORATION ASSESSMENT SUMMARY

Town of Dumfries
Prince William County, Virginia
June 28, 2013

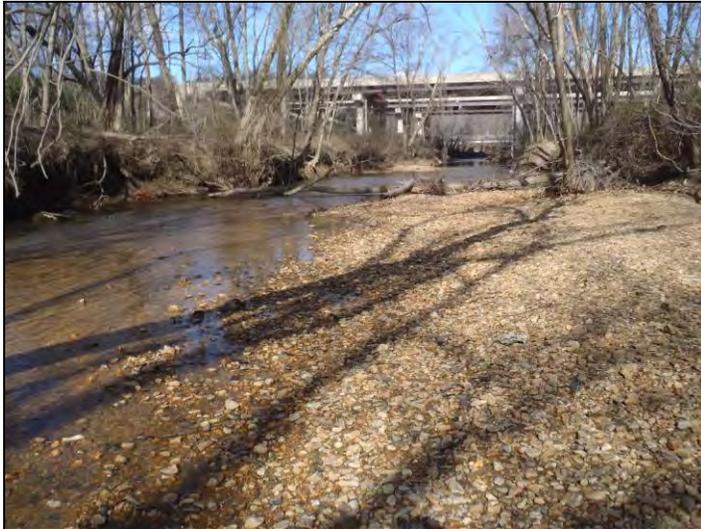
Reach 1: Typical channel and gravel bar formation

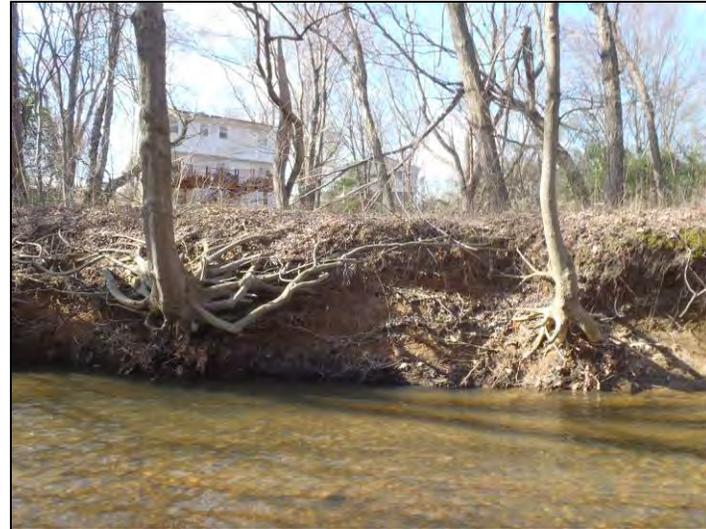
Reach 1: Left bank instability

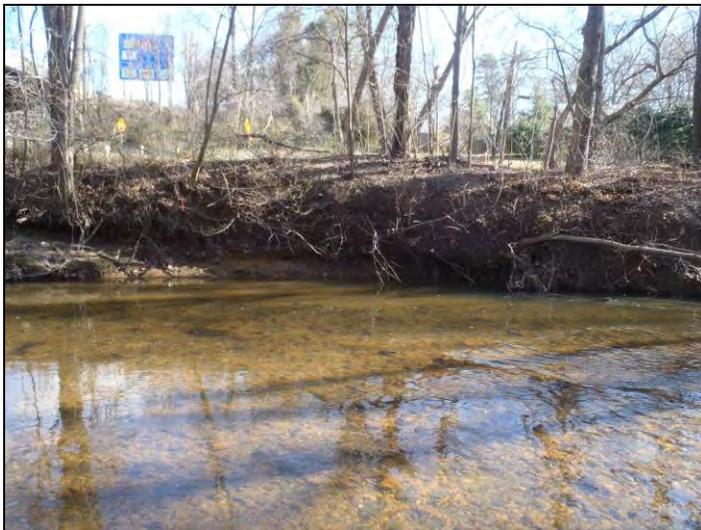
Reach 1: Right bank instability

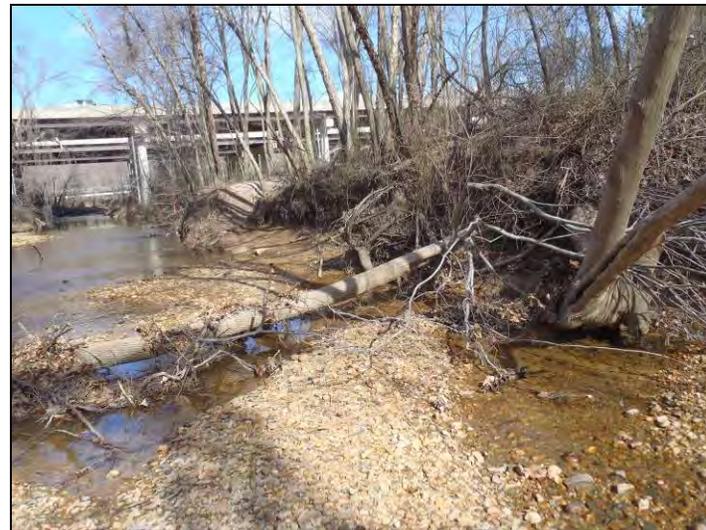
Reach 1: Bar formation, bank instability, and woody debris

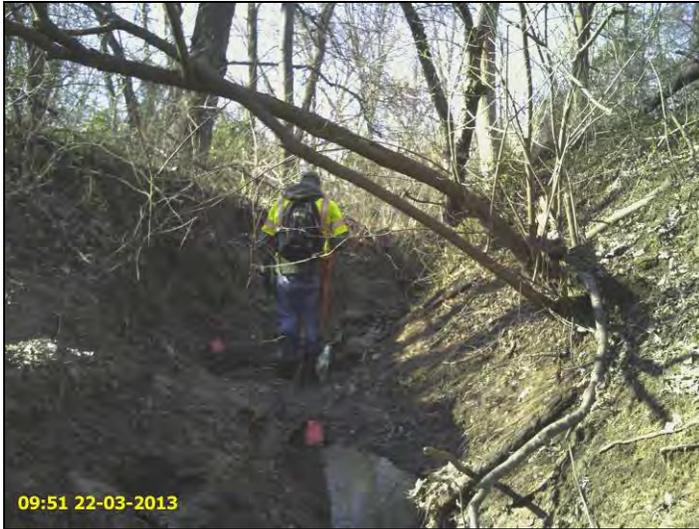
Reach 1: Outfall P

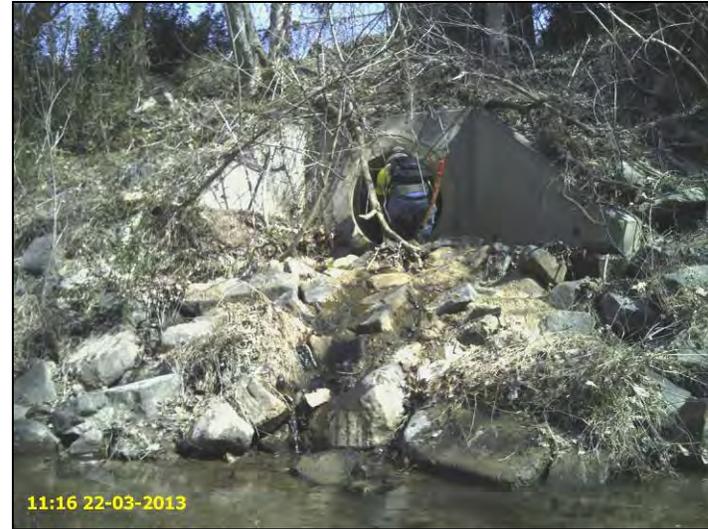
Reach 2: Outfall R

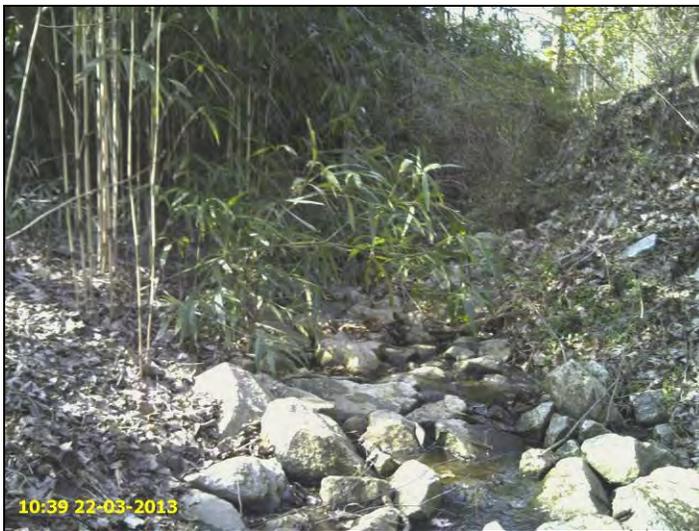
Reach 2: Outfall O and bamboo

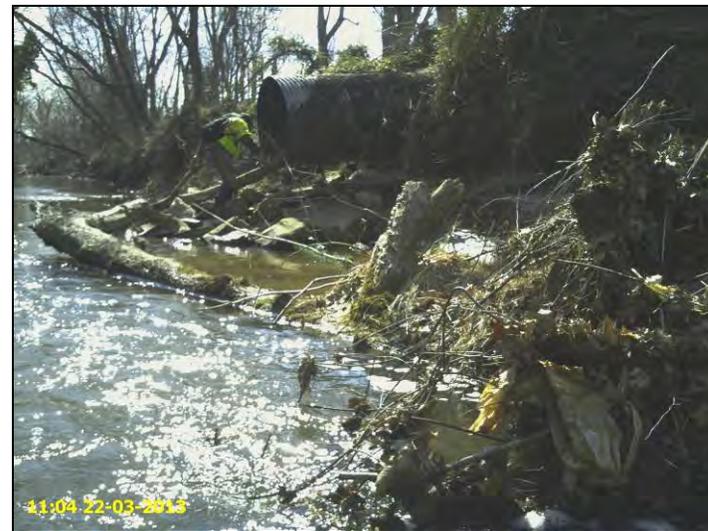
Reach 2: Outfall N and woody debris

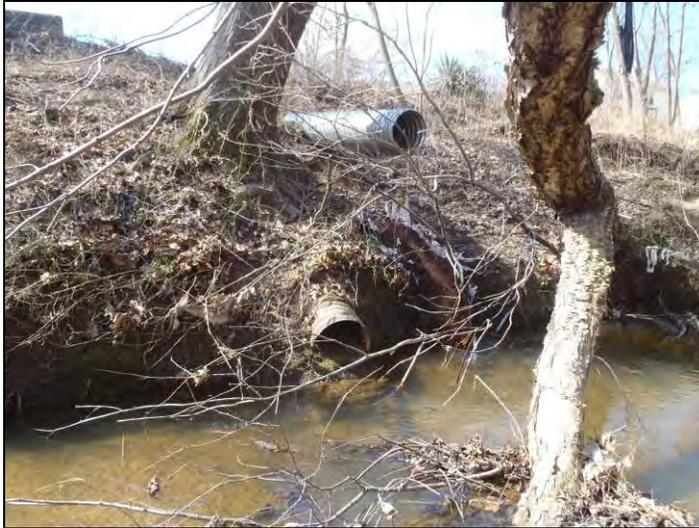
Reach 2: Outfall K

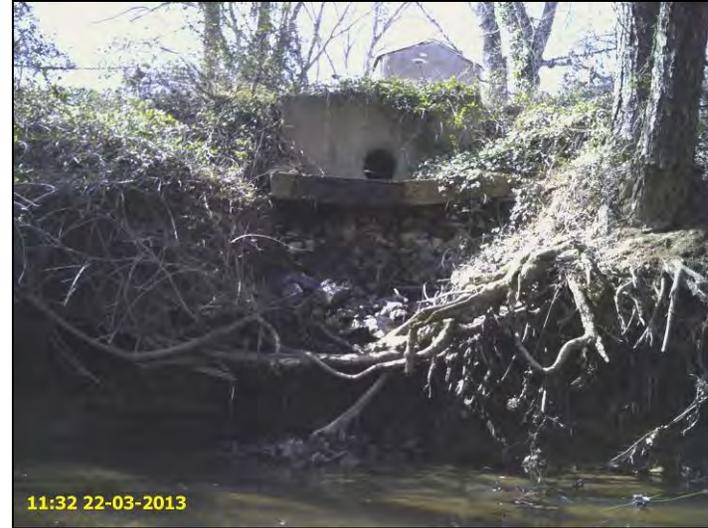
Reach 2: Outfall M and undercut tree

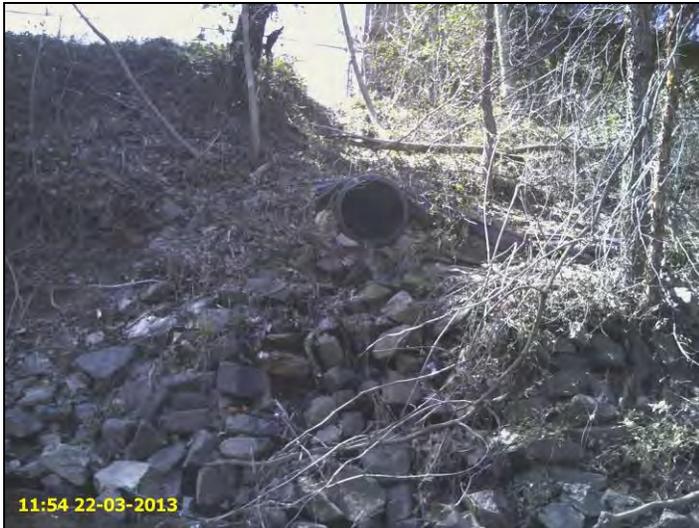
Reach 2: Outfall L

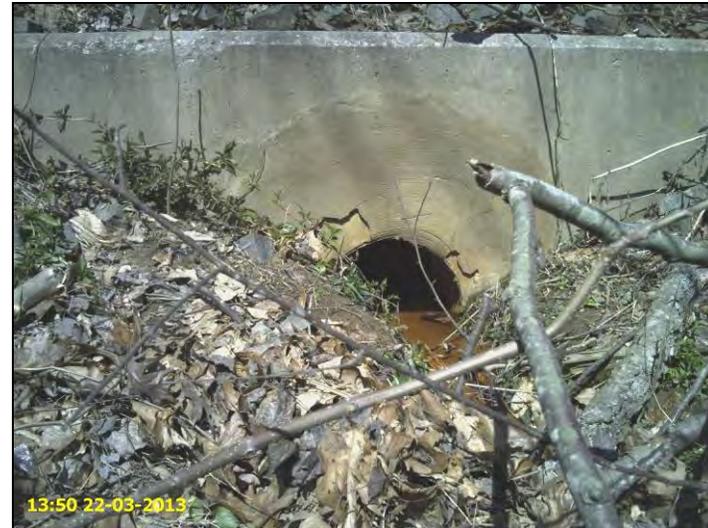
Reach 2: Outfall New 2

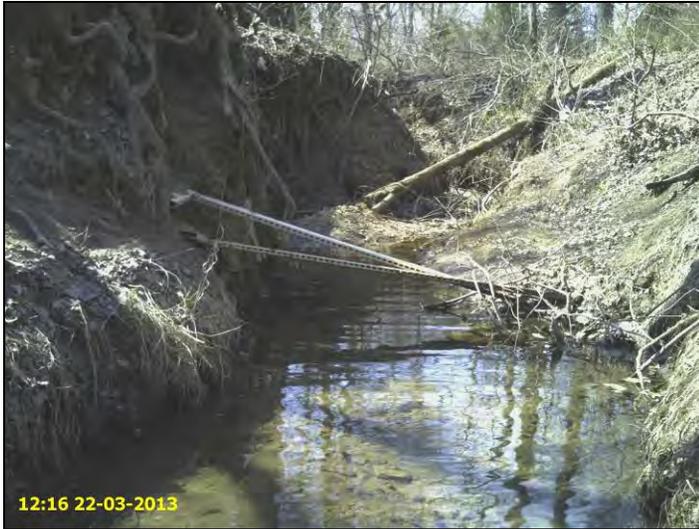
Reach 2: Outfall J at confluence

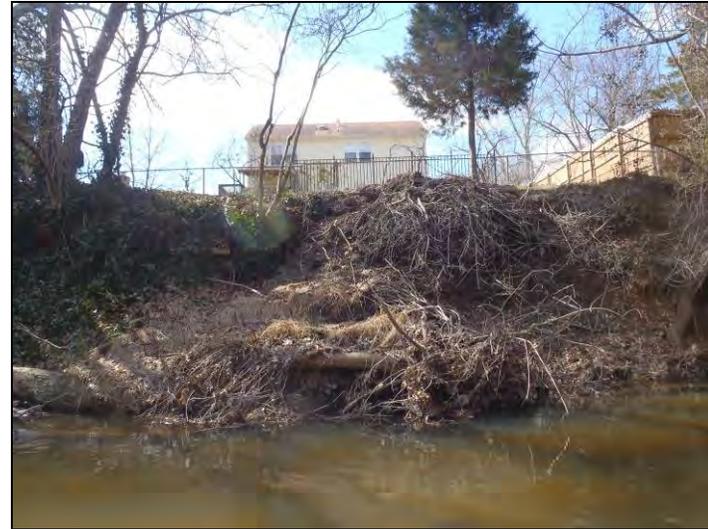
Reach 2: Fence along top of bank

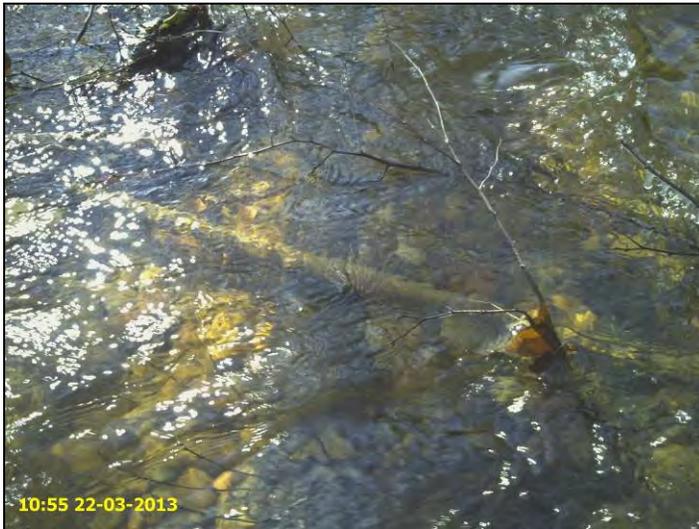
Reach 2: Exposed utility pipe

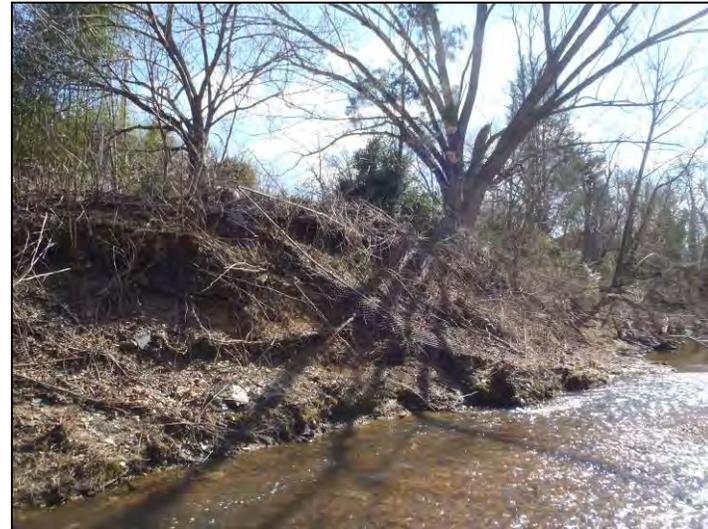
Reach 2: Left bank instability and fallen fence

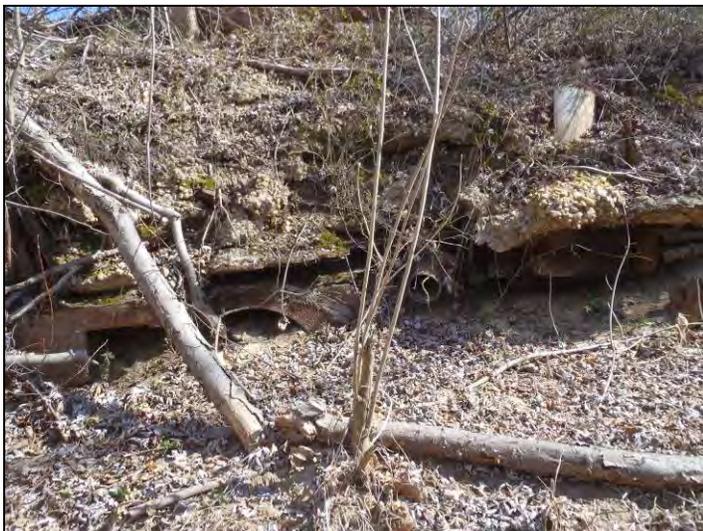
Reach 2: Outfall S and debris in left bank

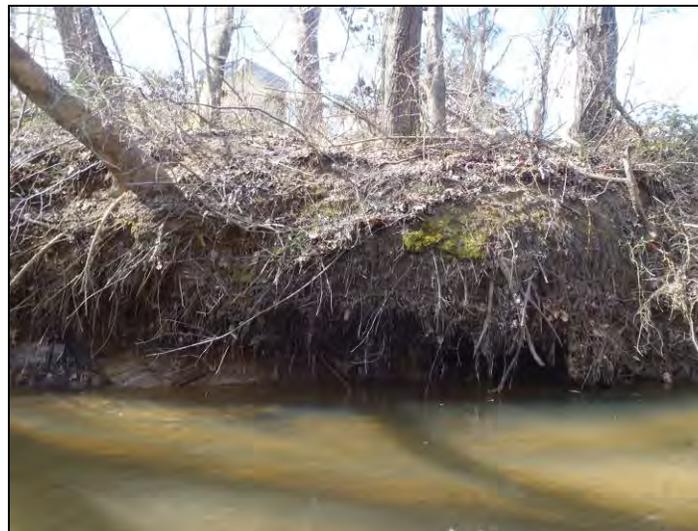
Reach 2: Right bank instability

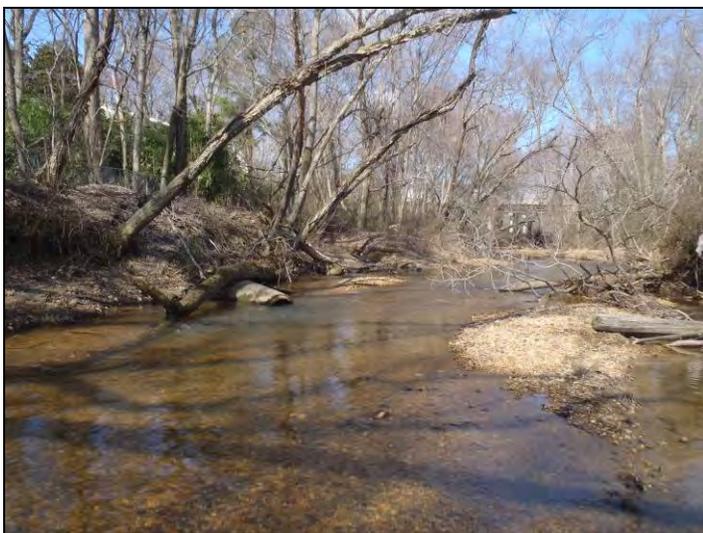
Reach 2: Typical channel upstream of Outfall ? with bars, gravel substrate, and riffles

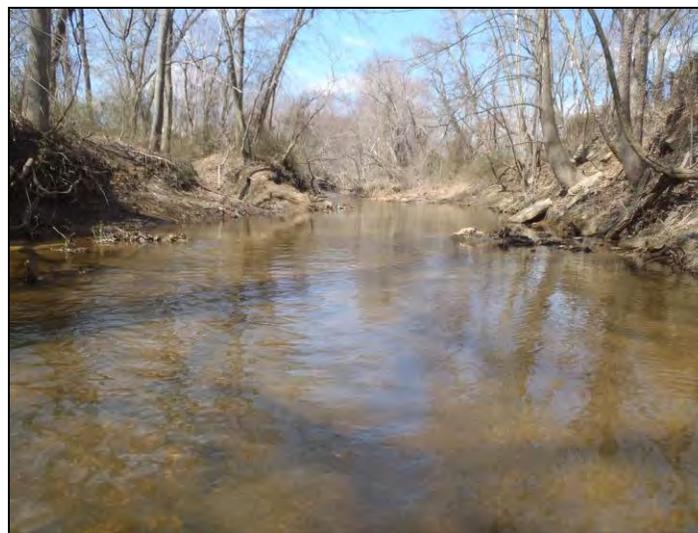
Reach 2: Typical channel downstream of Outfall ? lacking riffles and bars and with sand substrate

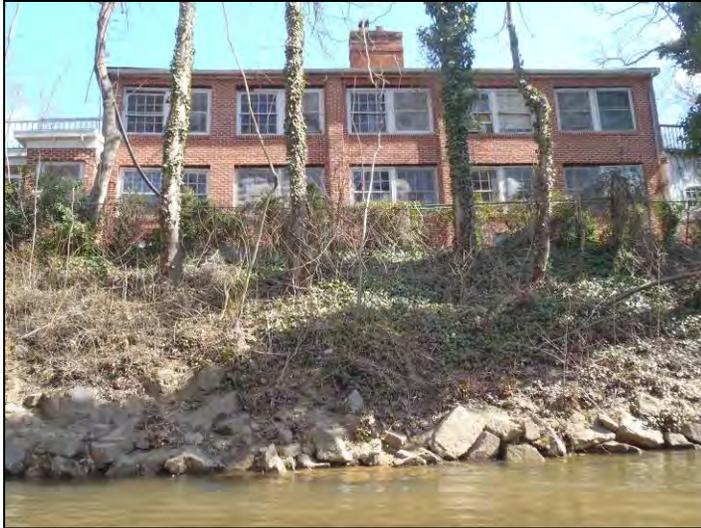
Reach 2: Grouted riprap and infrastructure at top of left bank

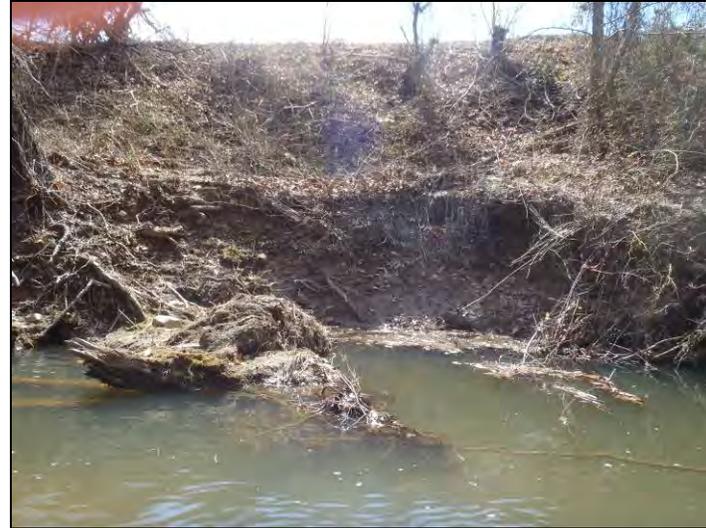
Reach 2: Left bank failure and lack of riparian vegetation

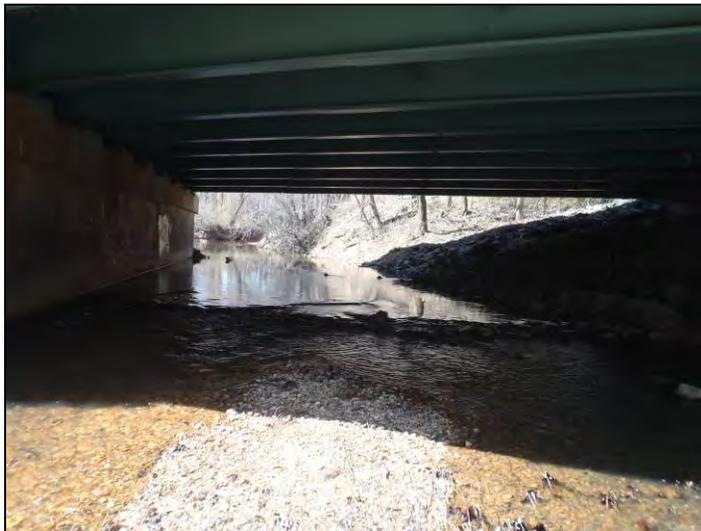
Reach 3: Grade control under bridge and bar formation

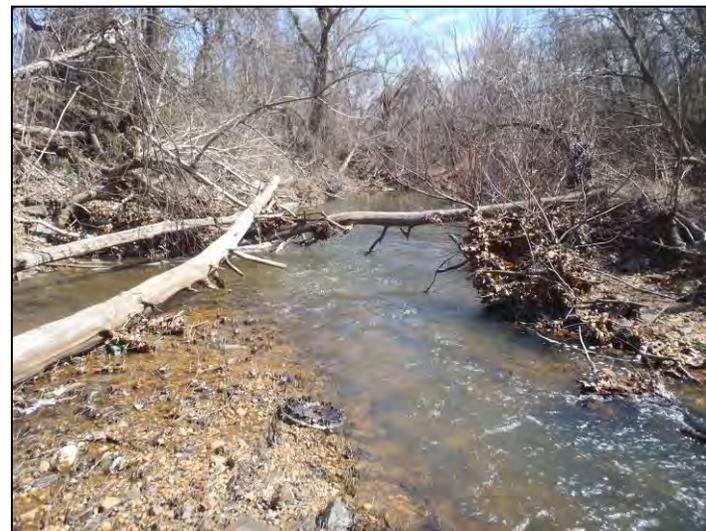
Reach 3: Mid-channel bar with woody debris along riffle

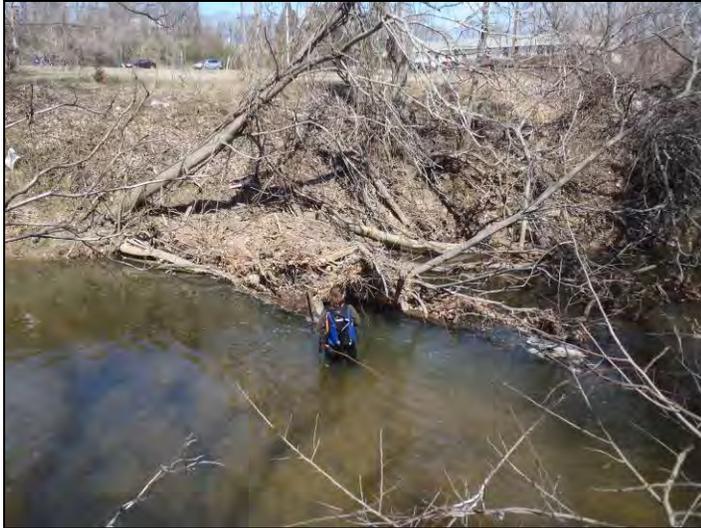
Reach 3: Left bank failure and lack of riparian
Vegetation

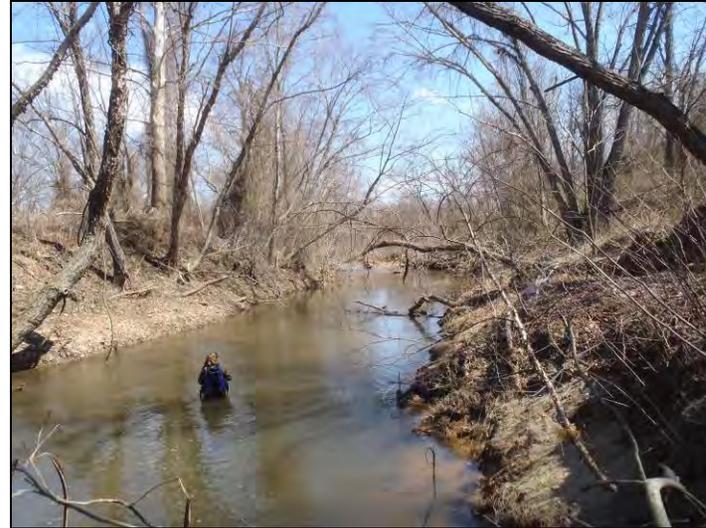
Reach 3: Typical channel without bench

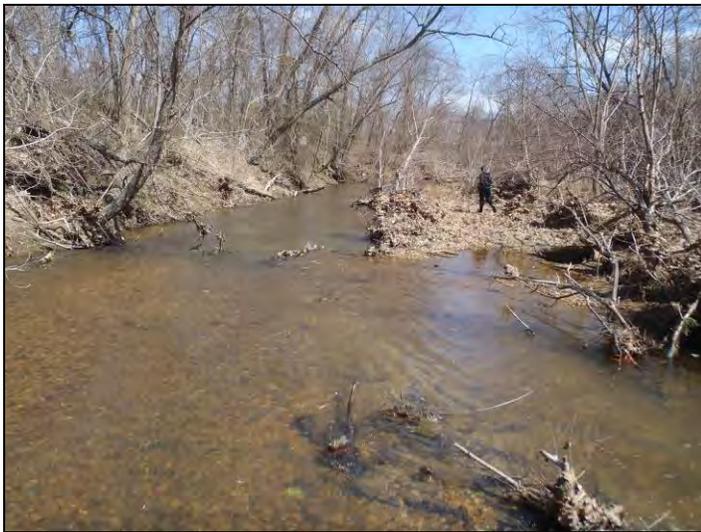
Reach 3: Typical channel with bench

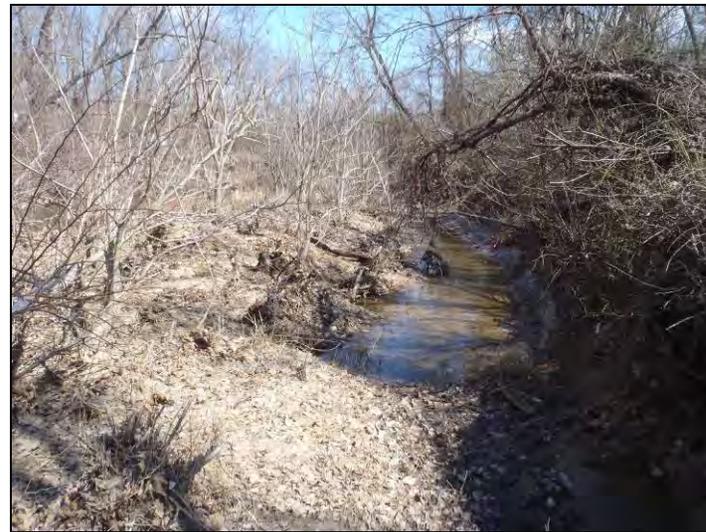
Reach 3: Secondary channel along bench

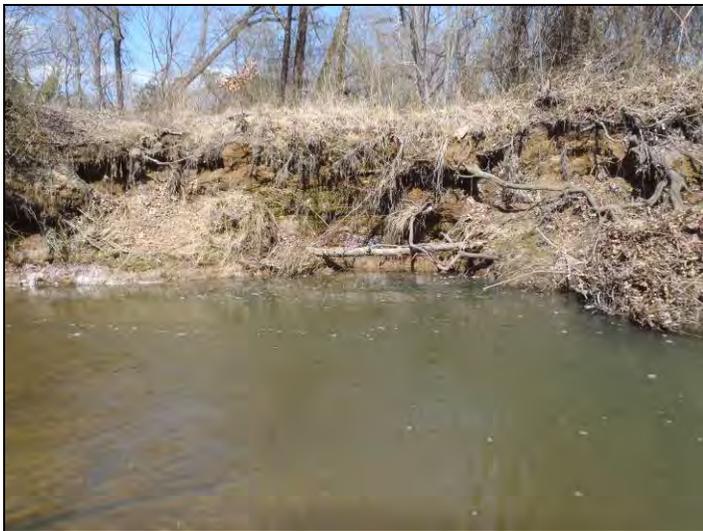
Reach 3: Left bank instability

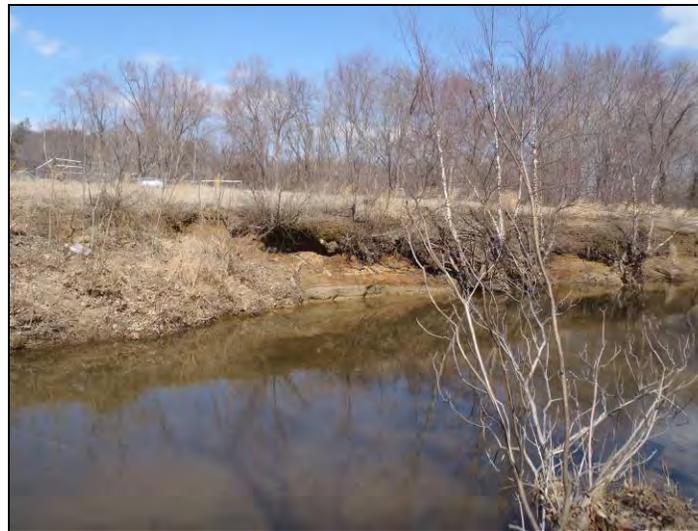
Reach 3: Left bank instability and lack of riparian vegetation near baseball field

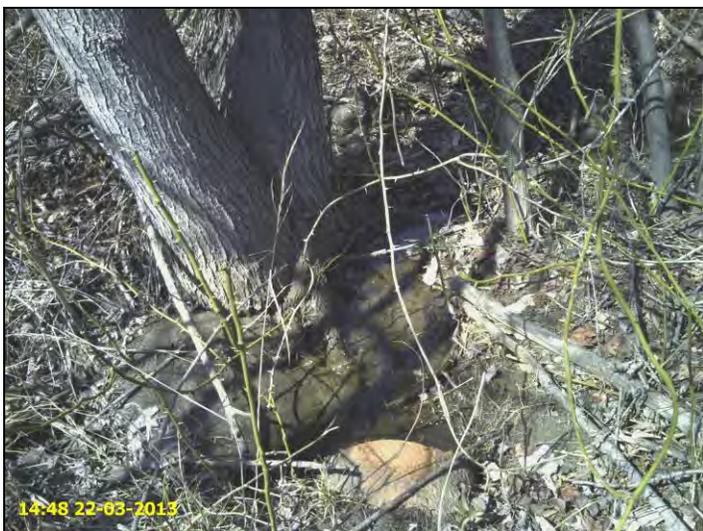
Reach 3: Outfall F

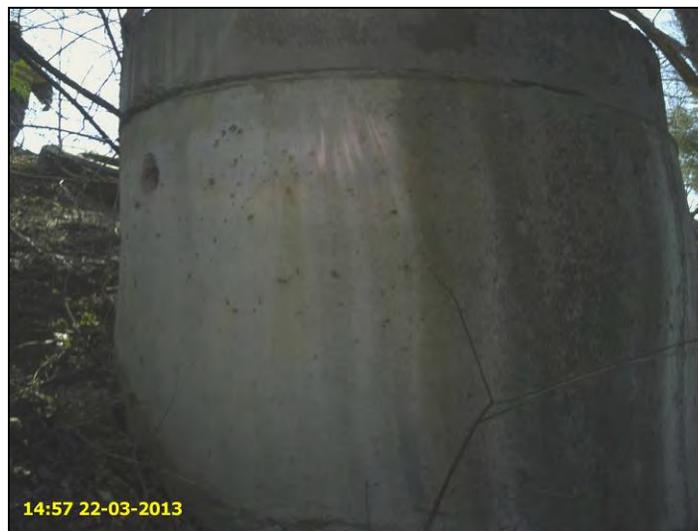
Reach 4: Outfall New 3 drop structure (without lid)

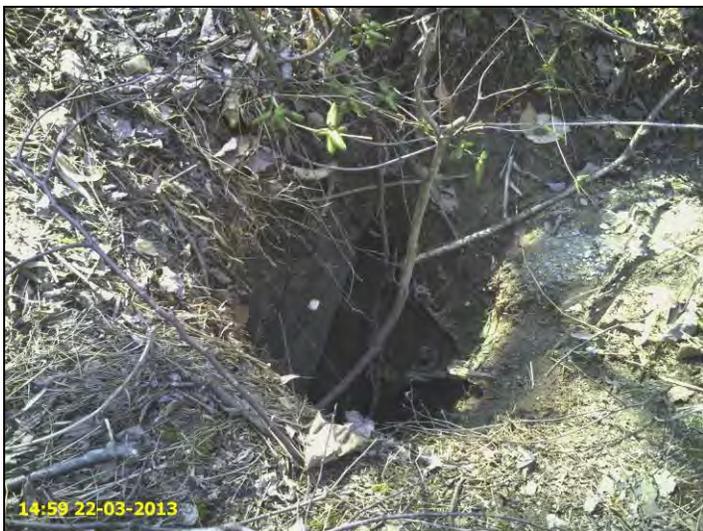
Reach 4: Outfall New 3

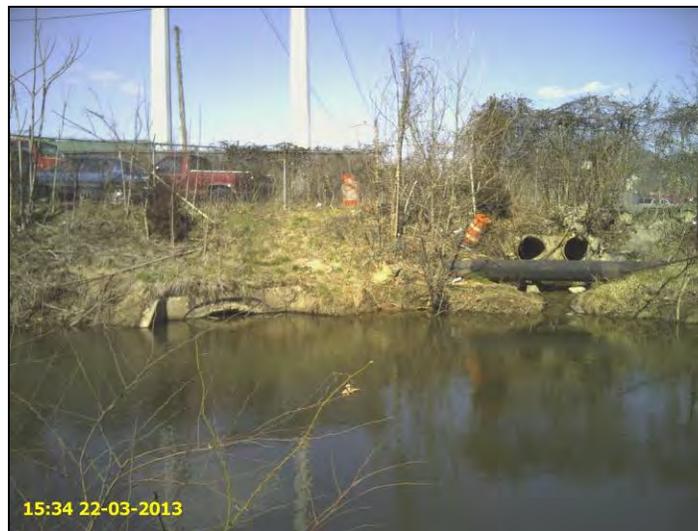
Reach 4: Outfalls AA and AB

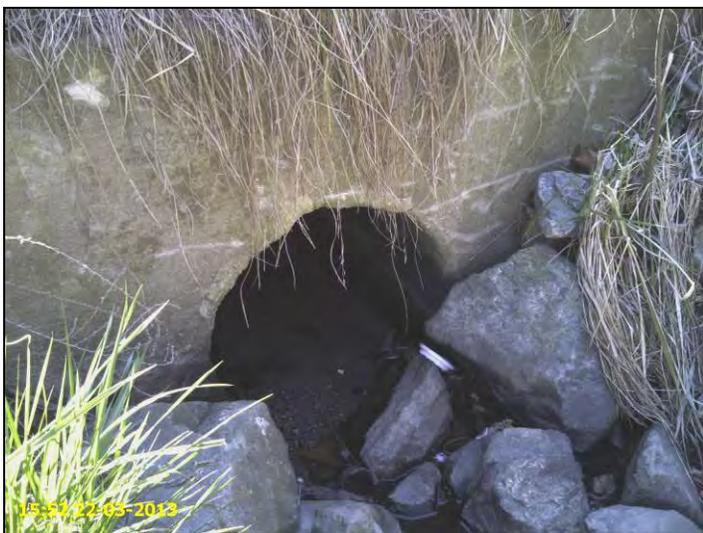
Reach 4: Outfall E

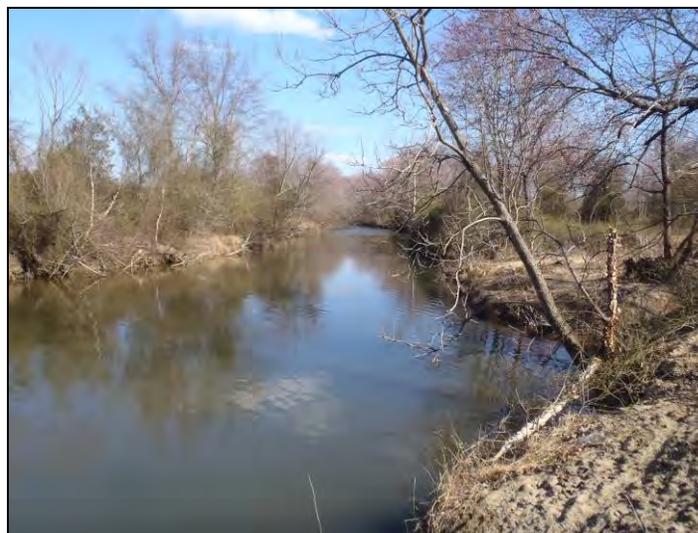
Reach 4: Typical channel

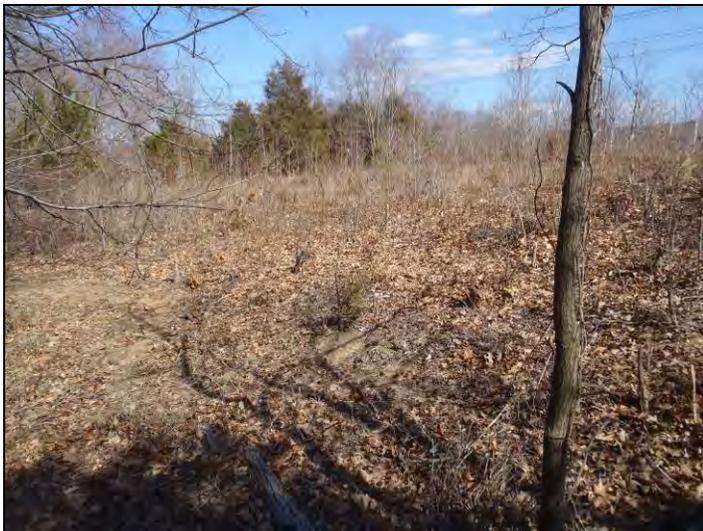
Reach 4: Saplings on right floodplain

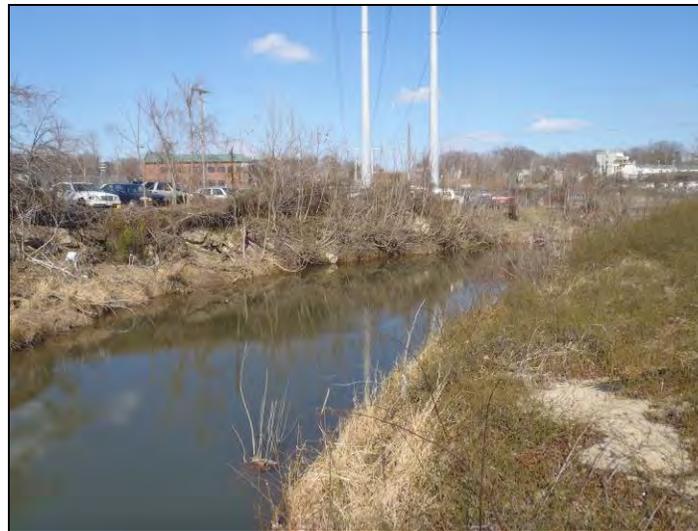
Reach 4: Parking lot to top of left bank, greenbrier on right bank

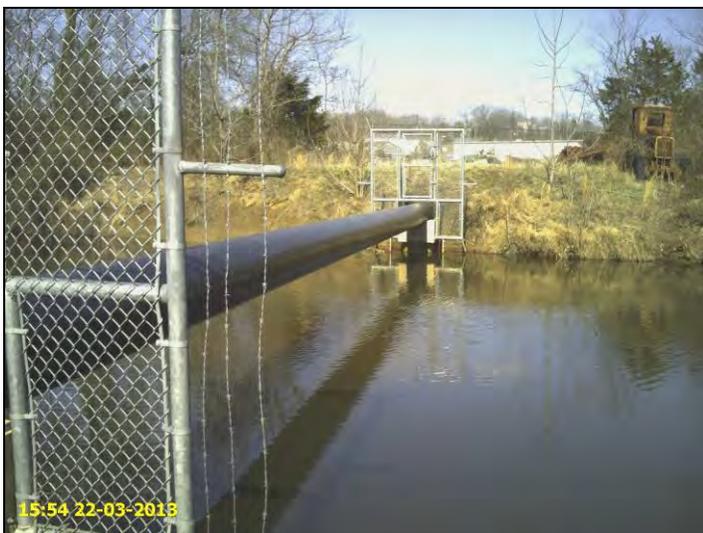
Reach 4: Pipe crossing stream

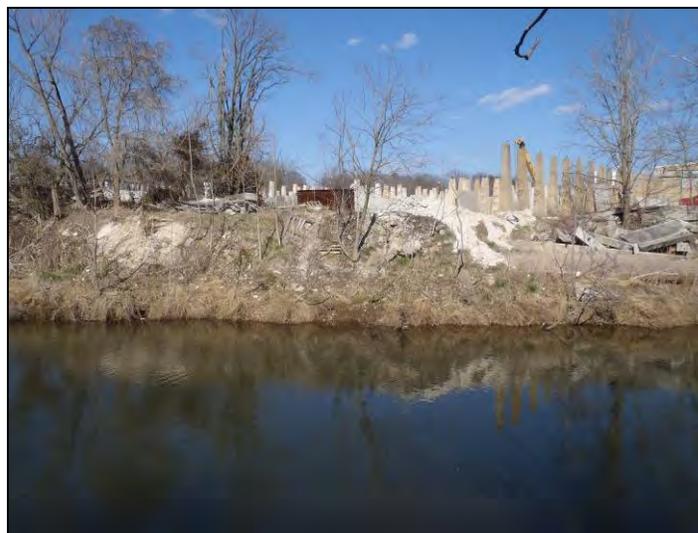
Reach 4: Infrastructure to top of left bank

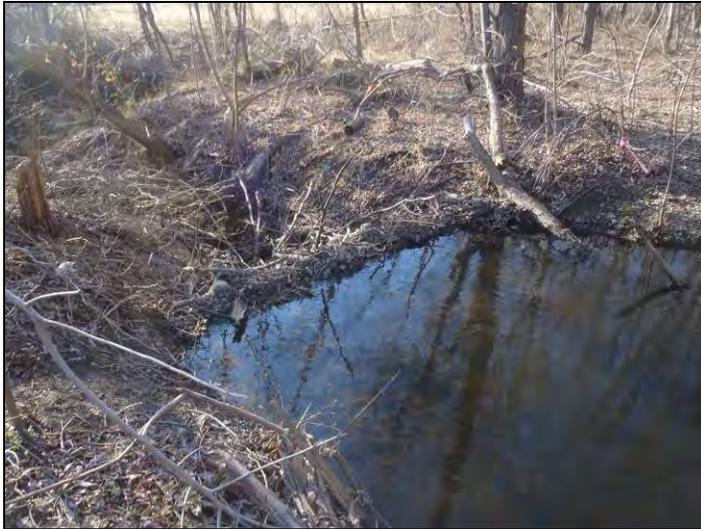
Beaver dam on tributary west of Fraley Blvd

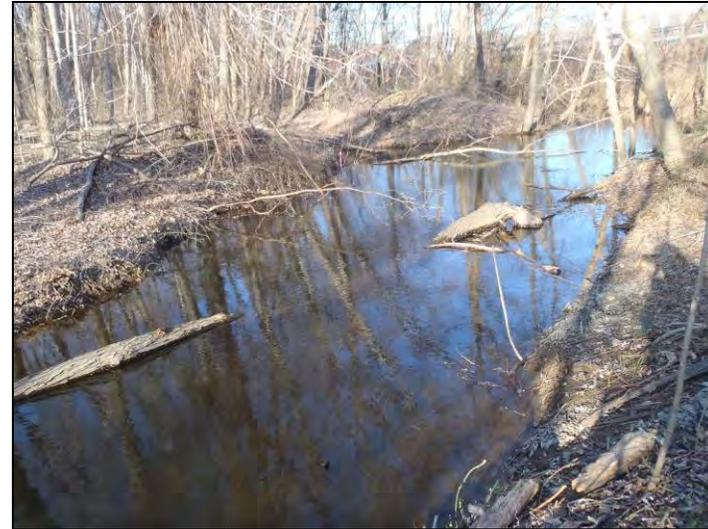
Backwater from Beaver dam
