AGENDA ITEM: Quantico Creek Stream Restoration Assessment Summary

QUANTICO CREEK STREAM RESTORATION ASSESSMENT SUMMARY

Town of Dumfries
Prince William County, Virginia
January 2014

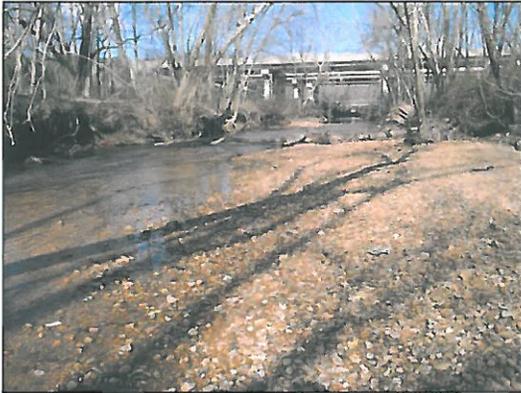
Reach 1: Typical channel and gravel bar formation

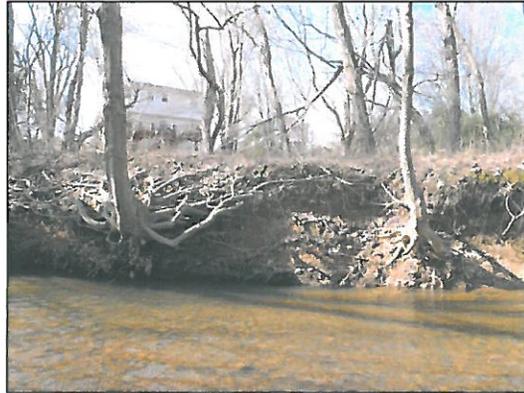
Reach 1: Left bank instability

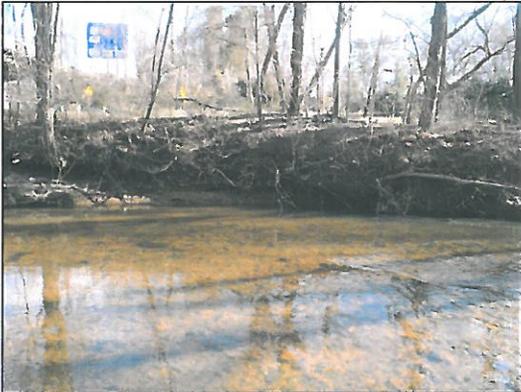
Reach 1: Right bank instability

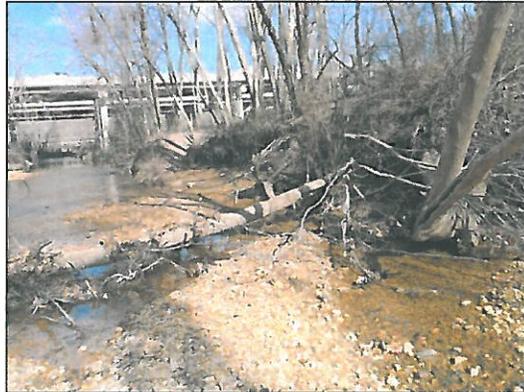
Reach 1: Bar formation, bank instability, and woody debris

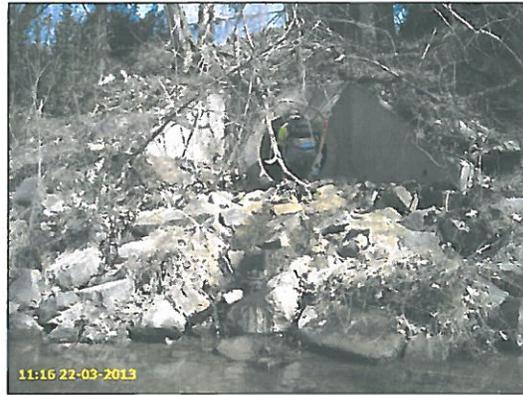
Reach 2: Outfall R

R	4'	11'	Yes	low	low	42" RCP EW	Grouted Flip Rap	Yes	Residential	None	
S	6'	0'	No	medium	low	18" RCP, PP	None	Yes	Residential	None	Appears to be abandoned in place
M	9'	4'	Yes	medium	low	12" RCP, HW	Conc. Cantilevered Apron	No	Residential	Remove 10' of pipe reconstruct EW, add step pool/scour hole	Entire HW structure and several trees threatened by undercut banks
T	10'	50'	No	high	low	24" Conc. ES, to channel	Rip Rap	No	Mine Rd	Step Pool	Outfall Structure Stable, channel stream confluence degraded
L	6'	3'	No	medium	low	24" HPDE, FIP	Rip Rap	Yes	15' Iron fence	None	
K	6'	1'	Yes	high	low	18" CMP, PP	None	No	Residential	Divert outfall around tree, add rip rap	Adjacent to abandoned CMP
U	7'	40'	Yes	high	low	18" Conc RCP, to channel	Recent Rip Rap to channel bed	No	Mine Rd	Channel stabilization/step pool	Channel is highly incised with head cuts and scour at confluence
J	20'	130'	Yes	high	low	60" CMP, conc HW, to channel	Rip Rap apron	No	Residential	Step Pool	Channel begins with stable rip rap apron but has several 4' vertical head cuts, some flow over bed rock. Channel at confluence highly incised w/ 12' high banks

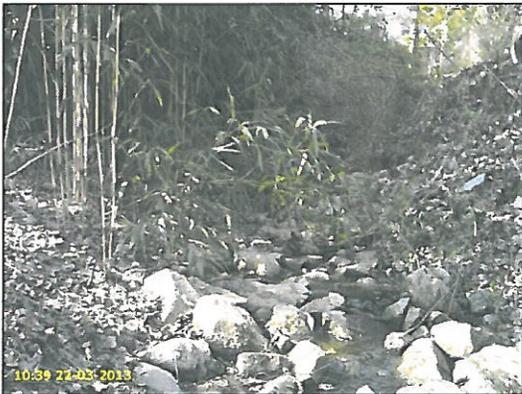
Reach 2: Outfall O and bamboo

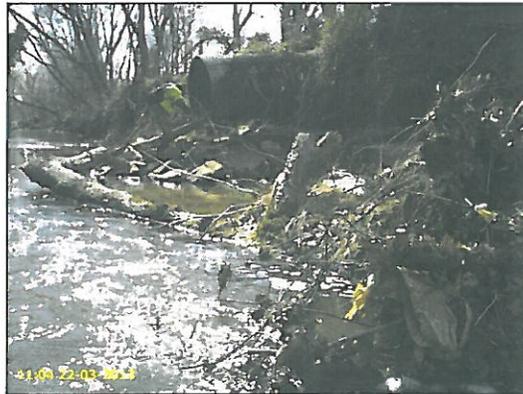
Reach 2: Outfall N and woody debris

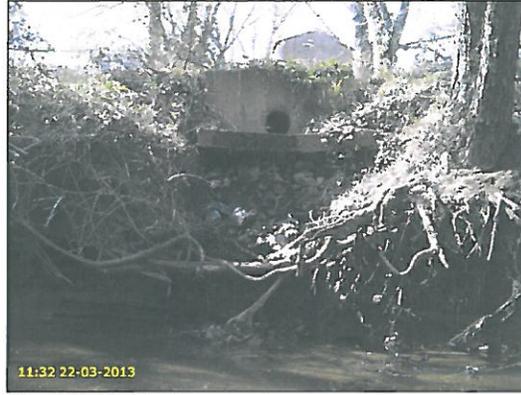
Reach 2: Outfall M and undercut tree

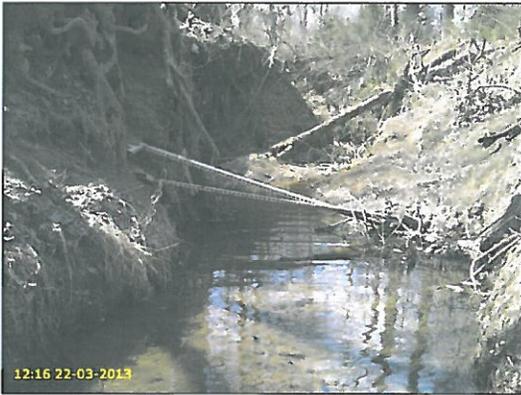
Reach 2: Outfall J at confluence

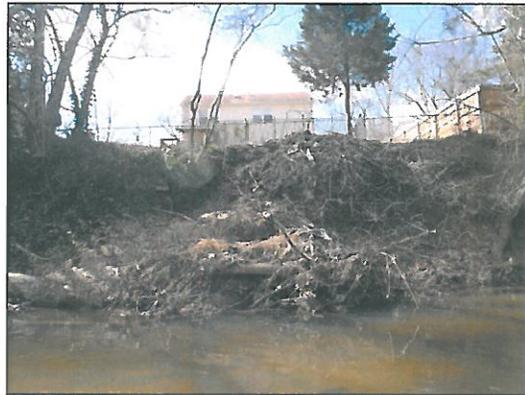
Reach 2: Fence along top of bank

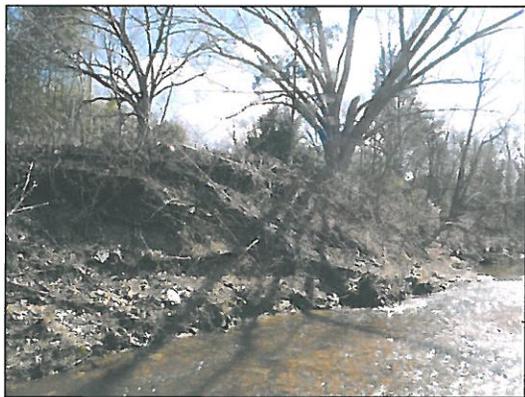
Reach 2: Left bank instability and fallen fence

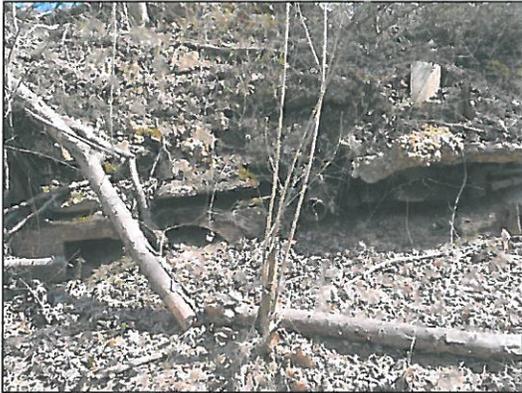
Reach 2: Outfall S and debris in left bank

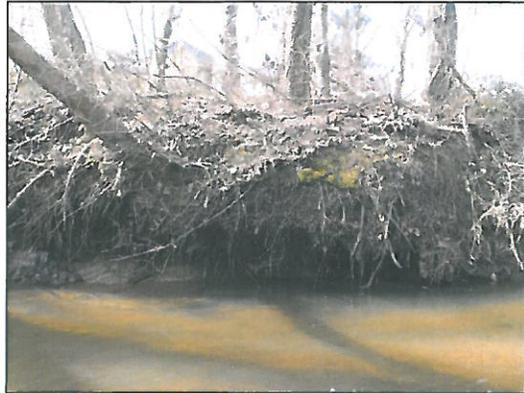
Reach 2: Right bank instability

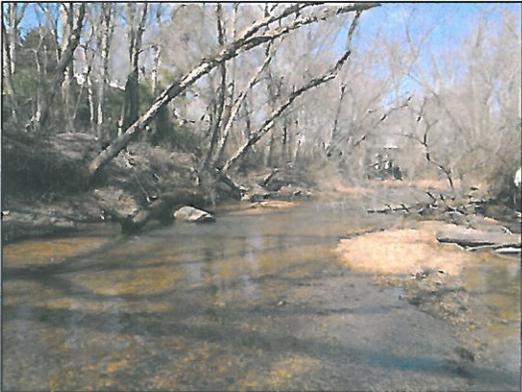
Reach 2: Typical channel upstream of Outfall ? with bars, gravel substrate, and riffles

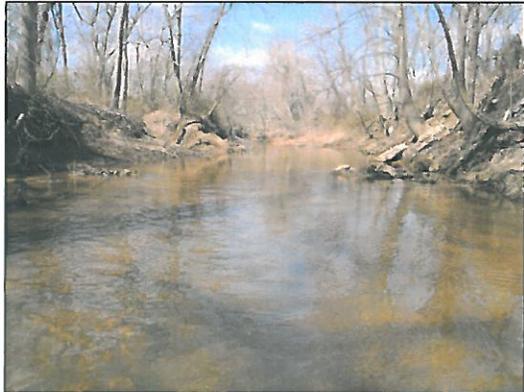
Reach 2: Typical channel downstream of Outfall ? lacking riffles and bars and with sand substrate

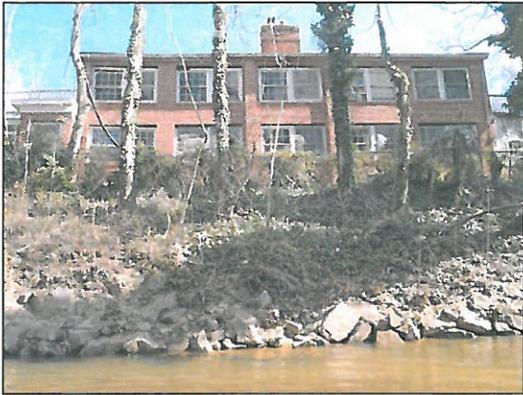
Reach 2: Grouted riprap and infrastructure at top of left bank

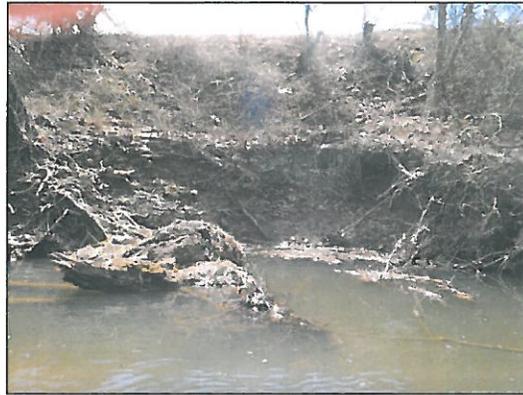
Reach 2: Left bank failure and lack of riparian vegetation

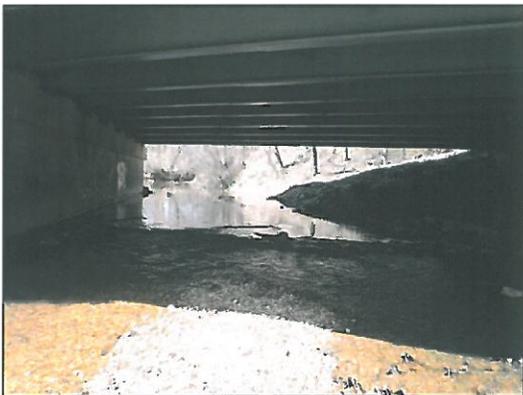
Reach 3: Grade control under bridge and bar formation

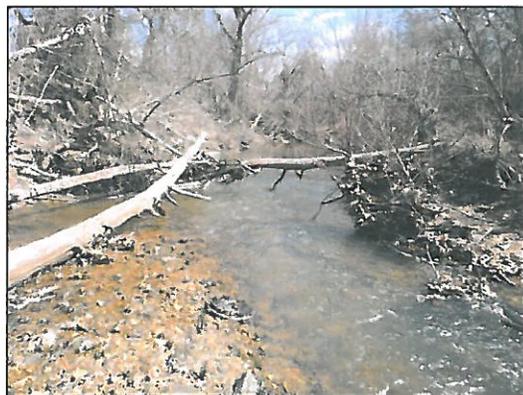
Reach 3: Mid-channel bar with woody debris along riffle

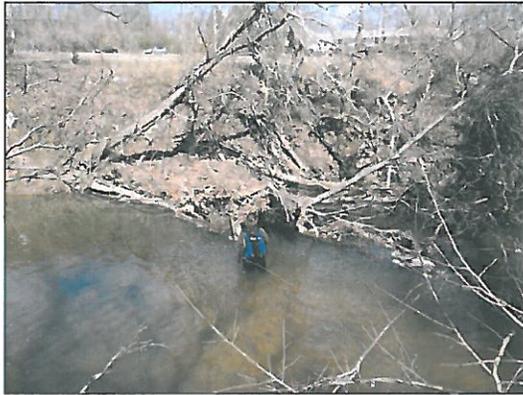
Reach 3: Left bank failure and lack of riparian
Vegetation

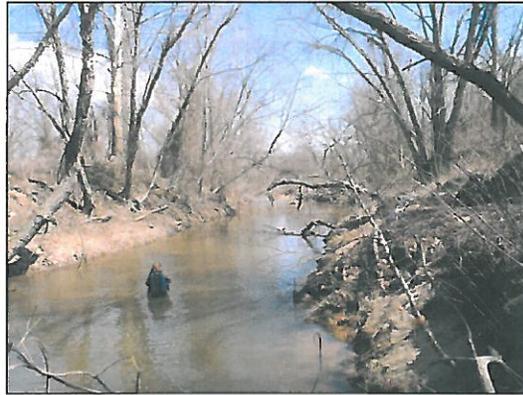
Reach 3: Typical channel without bench

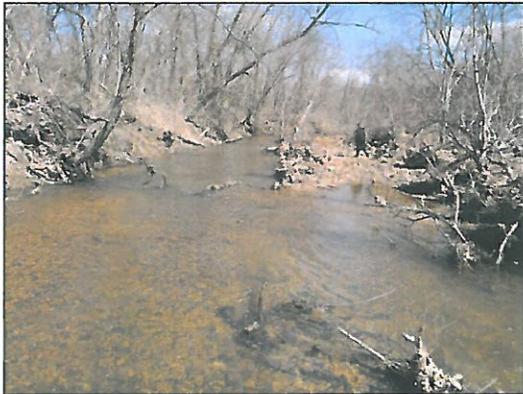
Reach 3: Typical channel with bench

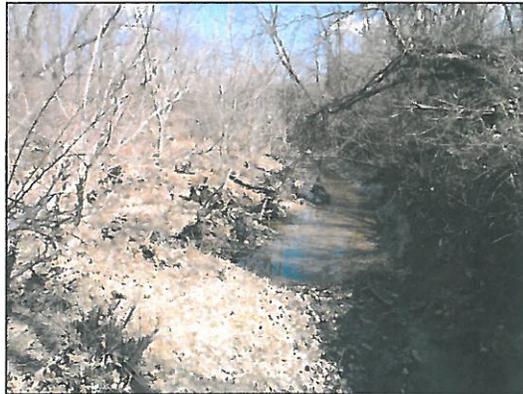
Reach 3: Secondary channel along bench

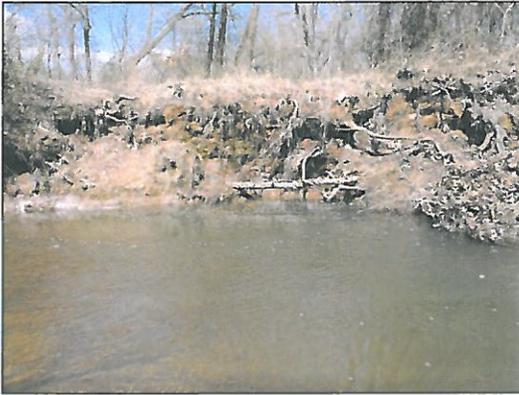
Reach 3: Left bank instability

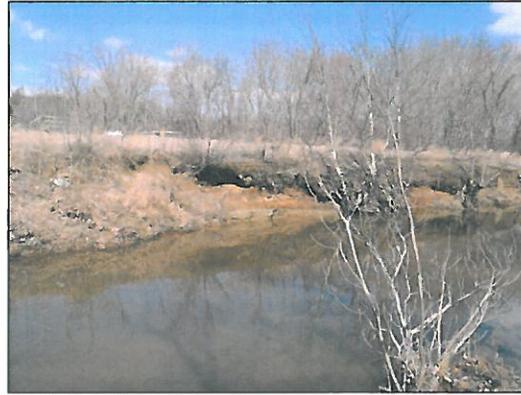
Reach 3: Left bank instability and lack of riparian vegetation near baseball field

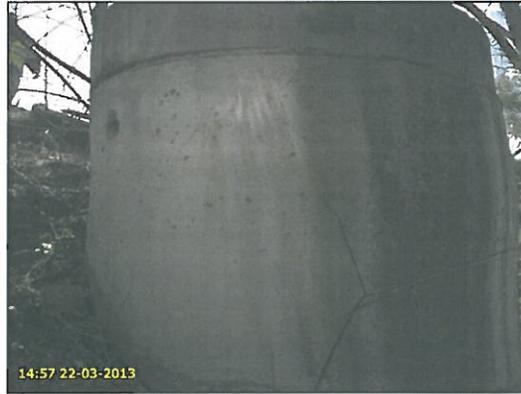
Reach 4: Outfall New 3 drop structure (without lid)

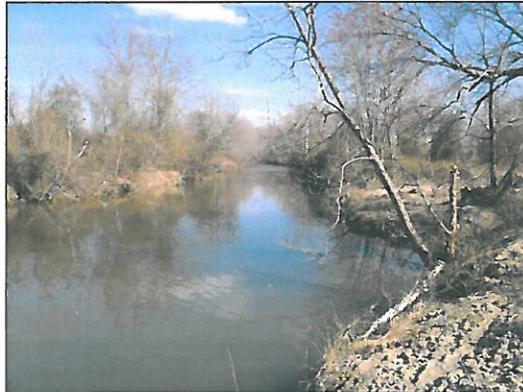
Reach 4: Typical channel

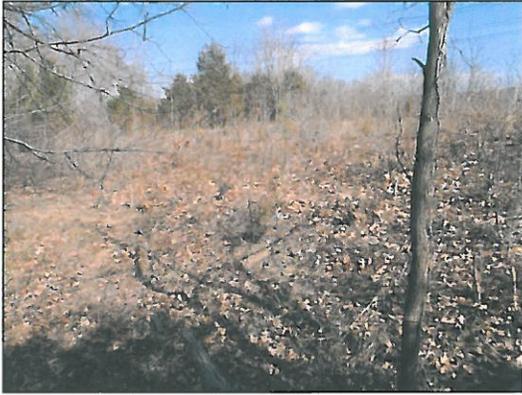
Reach 4: Saplings on right floodplain

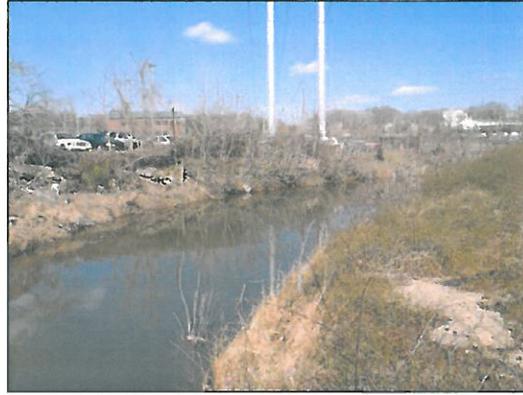
Reach 4: Parking lot to top of left bank, greenbrier on right bank

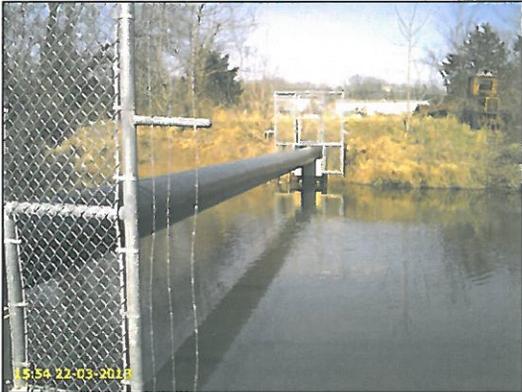
Reach 4: Pipe crossing stream

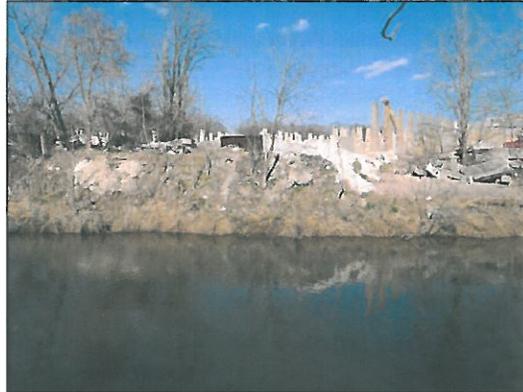
Reach 4: Infrastructure to top of left bank

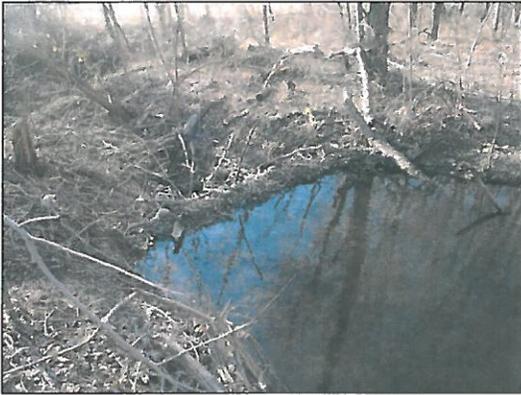
Beaver dam on tributary west of Fraley Blvd

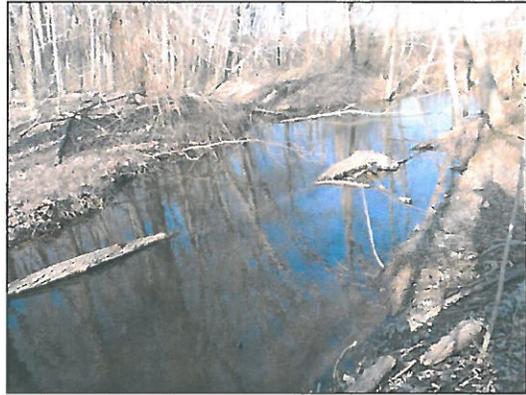
Backwater from Beaver dam
